Manhole Inspection Summary

Manhole # S17AA1072MH

Location Address: **GREENSPRING AVE**

Cross Street: **DRUID PARK DR**

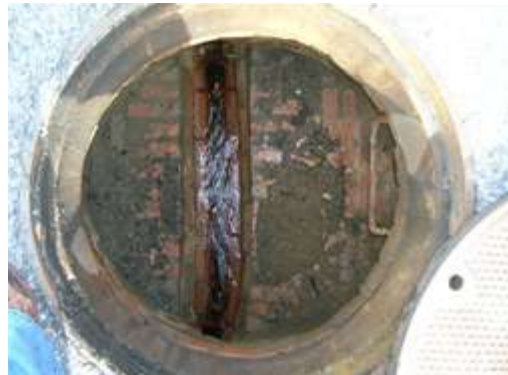
Top View

Corroded steps. Evidence of surcharge - Bench debris.

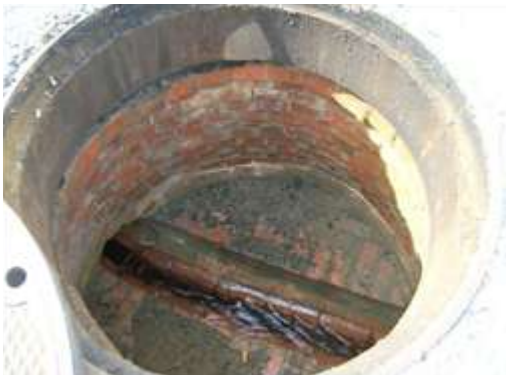
Defect

Frame leaks. Corbel deterioration and infiltration. Barrel infiltration - other side.

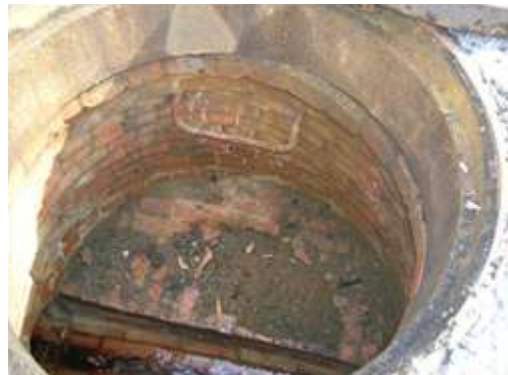
Defect

Frame leaks. Corbel deterioration and infiltration. Barrel infiltration.

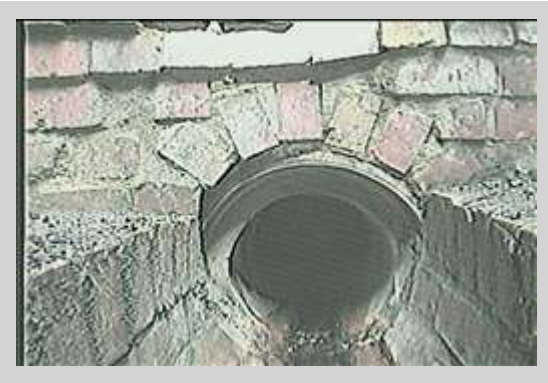
10 in. Circular Gravity Sewer Pipe Out @ 12 O'Clock

Channel deterioration.

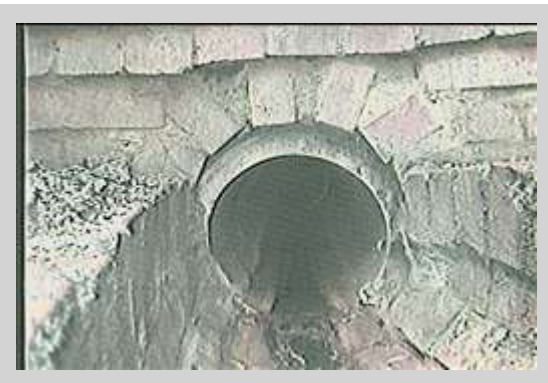
10 in. Circular Gravity Sewer Pipe In @ 6 O'Clock

Infiltration: **Evidence** Pipe Seal Cond: **Unknown**
